MISCELLANEOUS PAPER GL-81-8

EVALUATION OF MEMBRANE INTERLAYERS FOR PREVENTION OF CRACK REFLECTION IN THIN OVERLAYS

Philip J. Vedros, Jr.

October 1981

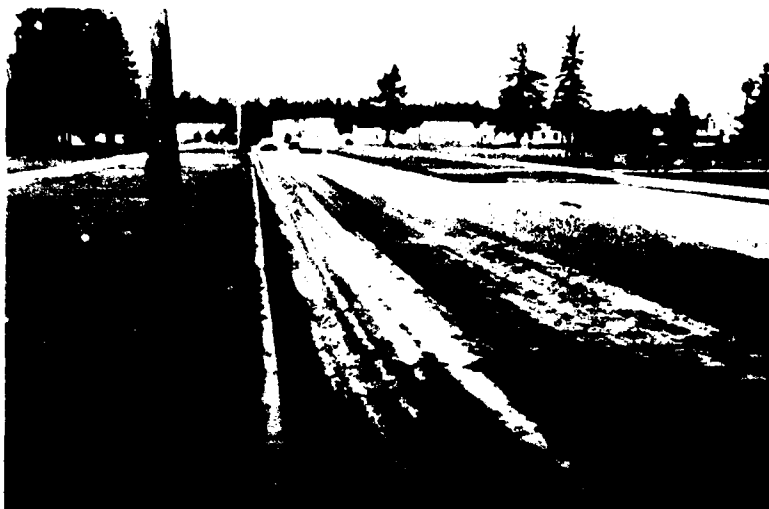
Second Division Drive was observed to be ravelling very severely in the wheel paths of the automobiles and at turn outs from the roadway (Photo 1). This condition was occurring mainly in the Sahuaro asphalt rubber sections, in both the uncoated and precoated chip areas. The U. S. Rubber chip seal area was observed to have a bare spot along the center line where the material was not applied during construction (Photo 2). The loose chips were swept from the roadway prior to the inspection in 1978 and very little change in the surface condition of the roadway has occurred since that time. The roadway has been inspected on an annual basis, and Photos 3 and 4 indicate the general condition at the time of the inspection in June 1981. The 25-ft-wide areas marked off to monitor the cracking by photographic means (Photos 5-7) indicated that only a very small crack has reflected in the section for the U. S. Rubber material. The control section of a standard 1-in. overlay was in excellent condition.

Photo 1. Asphalt-rubber seal placed by Sahuaro
ravelling in traffic wheel paths (note buildup
of loose chips at curb line)

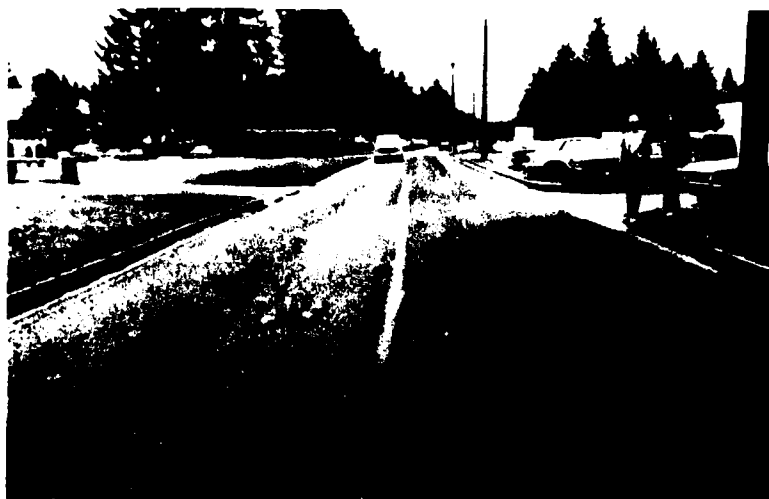
Photo 2. U. S. Rubber seal with bare spot at
center line. Area did not receive rubberized
material during construction

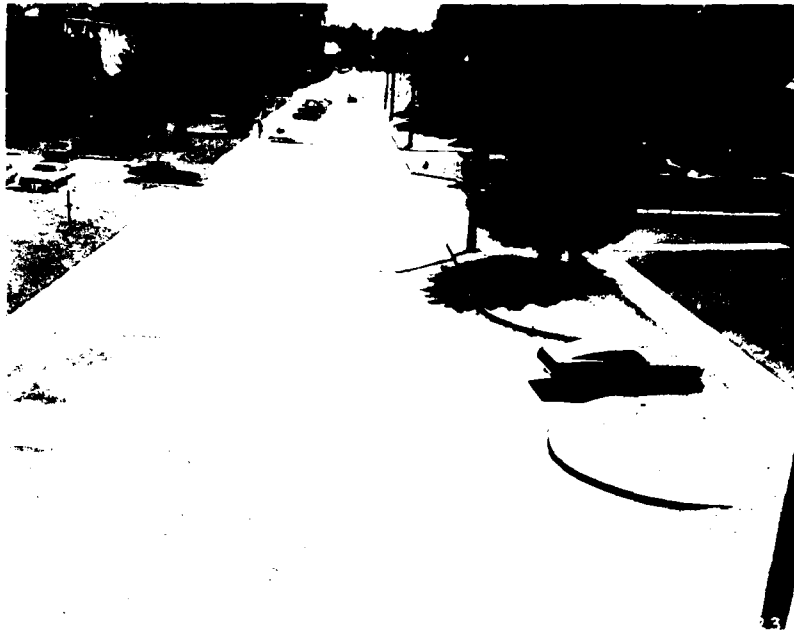
Photo 3. View of U. S. Rubber chip area, Second Division Drive, June 1981

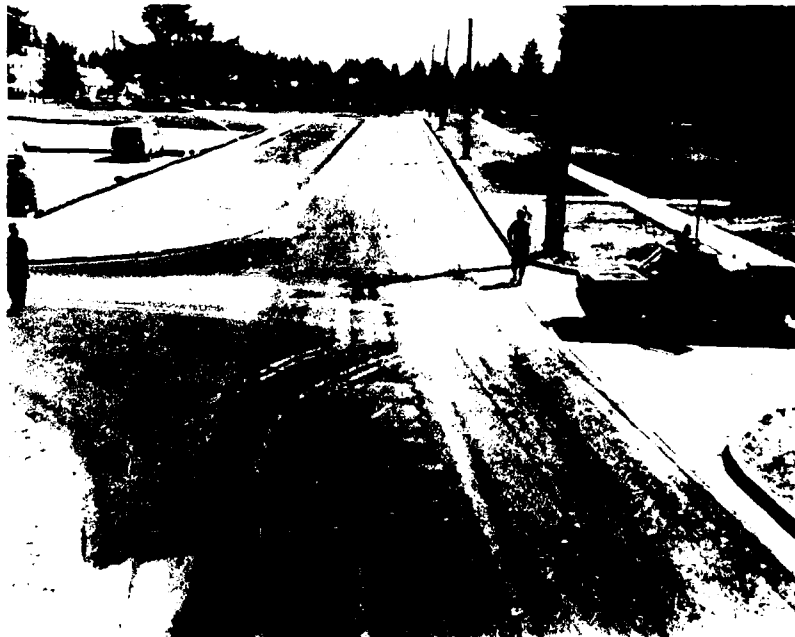
Photo 4. View of Sahuaro precoated chip area, Second Division Drive, June 1981

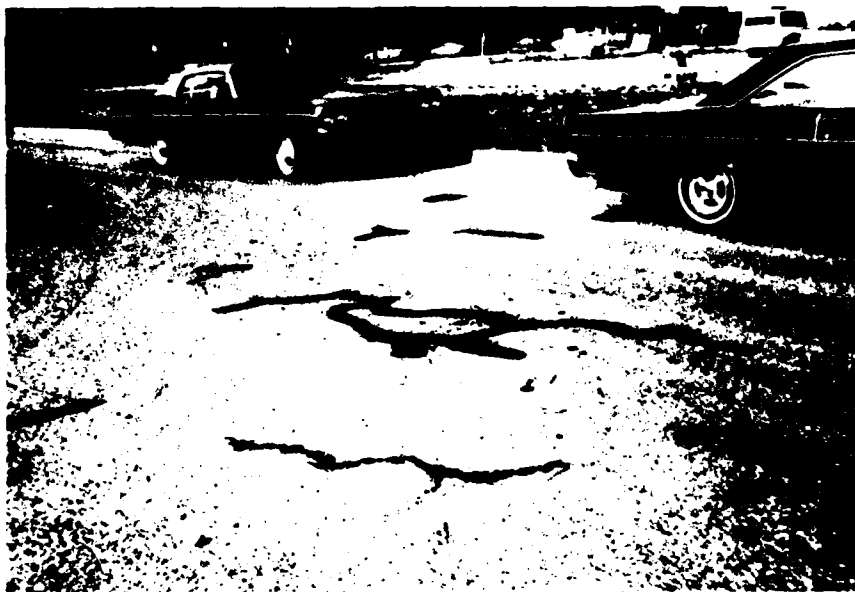
10. The cracking on Faith Avenue before application of the test materials was minor and tended to be localized. The cracks were sealed before application of the test materials (Photo 8). No measurement of the length of the cracking in each photographic test area was made of the original pavement before application of the test materials. The original cracking pattern can be seen in Photos 9 through 18. The first evidence of any cracking in the overlay on Faith Avenue was observed in February 1978. A fine hairline crack in the Mirafi 140 section on the southside was determined to be caused by a wrinkle in the fabric during construction (Photo 19). A reflection crack in the control section on the north side of Faith Avenue was observed in May 1978 (Photo 20). Table 1 presents a summary of the estimated percentage of reflection cracking that was observed in all test areas on Faith Avenue. As noted, the only sections that had cracking were the two sections of the Mirafi 140 fabric and one control section.

Photo 8. Cracks on Faith Avenue sealed
with AR-4000 asphalt

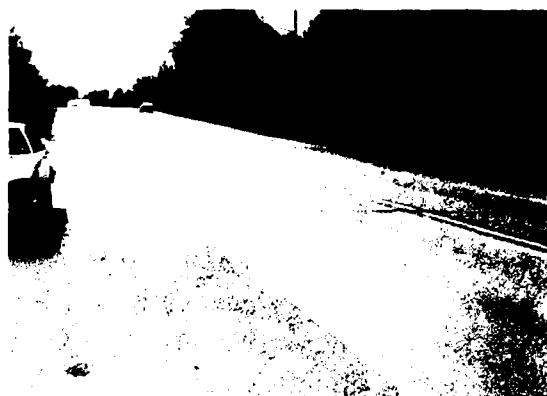
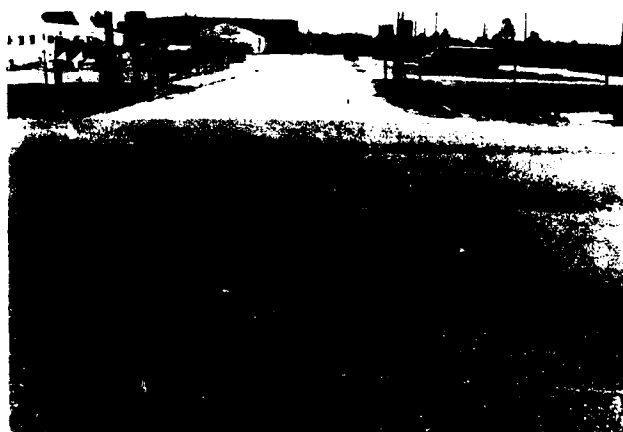
Photo 53. Joint condition on Louisiana Avenue

as compared with a 1-1/2-in. overlay where the fabric was placed. The sections were not inspected in 1979 or 1980. The inspection in June 1981 (Photo 53) indicated that 100 percent of the joint cracking had reflected in both the fabric area and the area where no fabric was used. Most of the cracks had been repaired and filled in 1980 in the area of the roadway where the Petromat fabric was used. However, the cracks in the 2-in. overlay section had not been repaired and sealed at this time, as noted in Photo 53.

- f. The use of a fabric on the portland cement concrete roadway at Fort Polk before placement of an asphaltic concrete overlay appears to be of no value in preventing joint reflection.
- g. A general conclusion on the results of this study would be that the use of these membranes in a cold environment does not prevent or retard reflection cracking from occurring. The use of an asphalt-rubber membrane in a warm climate may have some merits, and it is recommended that the base personnel continue to observe the test areas at Fort Stewart to see if the trend of limited reflection cracking in the asphalt-rubber membranes in the future will continue.

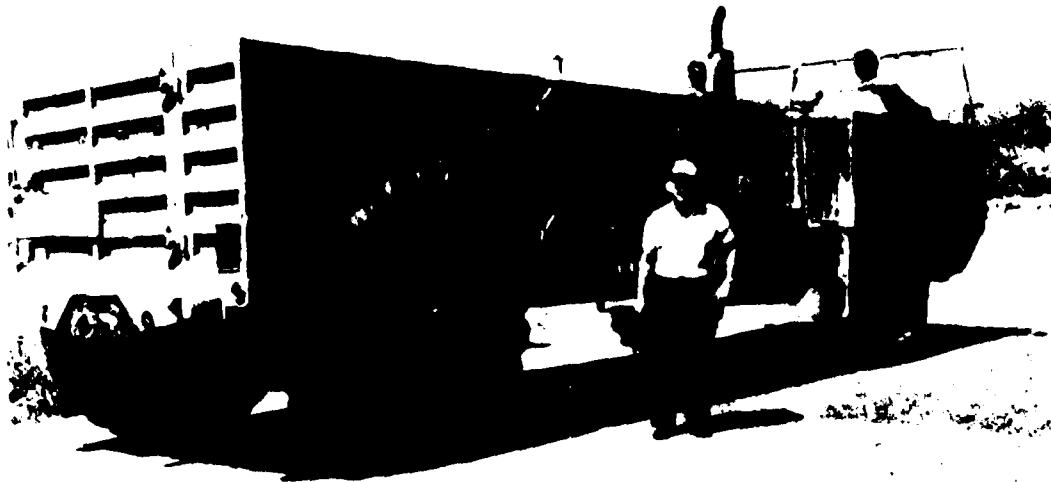
23. Wilderness Road is used frequently by trucks hauling explosives from the ammo storage area located adjacent to the road (Photo 54). The large trucks broke the pavement surface along the edges (Photo 55) and thus narrowed the width of the roadway to about 20 ft. The area between the white stripes (Photo 56) was essentially left intact during the repair work, and the edges were widened 2 ft on each side with gravel shoulders (Photo 57). As shown in Figure 5, there were 12 test sections, two for each type of material. Photos 58 through 69 indicate the crack pattern that existed in the selected photographic areas before placement of test materials and the progression of reflection cracking through these materials to the end of the last inspection in June 1981. These photographs also show that the alligator-type cracking along the edge of the roadway is the same condition as shown in Photo 56 that was left intact in the repair work. The initial length of cracking in each section was not measured before placement of the test materials.

Photo 54. Vehicle used to haul explosives
from ammo storage area

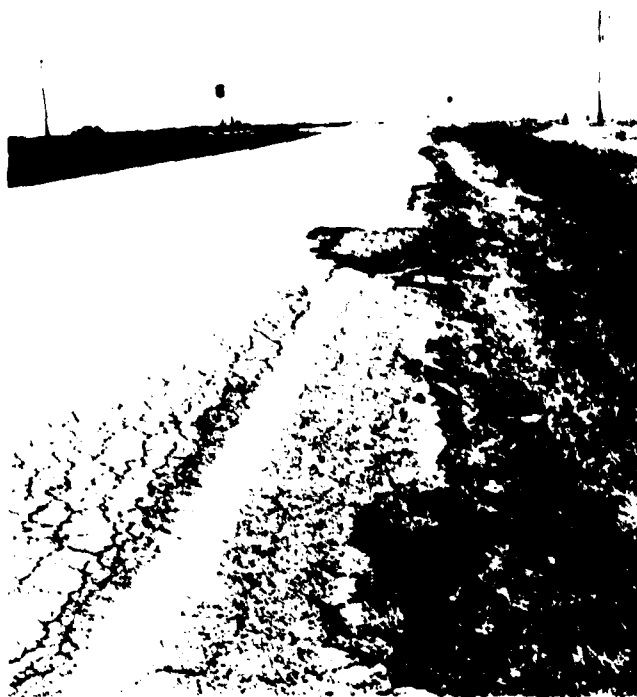
Photo 55. Condition of Wilderness Road
before repair, May 1978

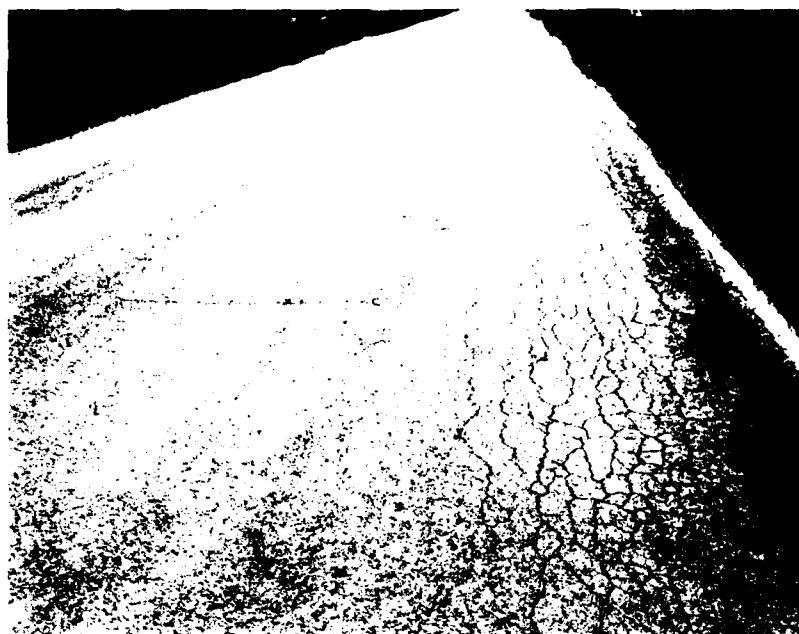
Photo 56. Road not repaired between
white stripes
